Test report No 13051A

A glazed partition.

Test concerning the fire resistance of this test specimen in accordance with the European standard EN 1364-1: 1999.

PYROBELITE 12 in a Jansen Economy 50 frame.

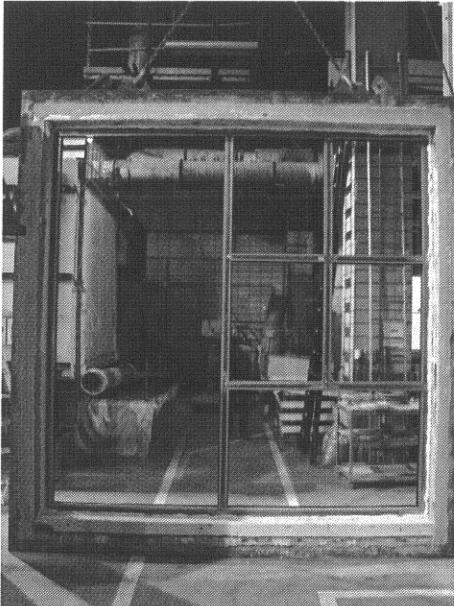
The exposed side before the test.

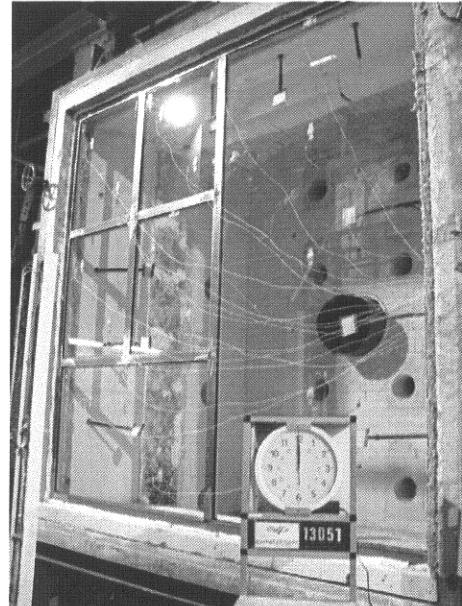
The un-exposed side before the test

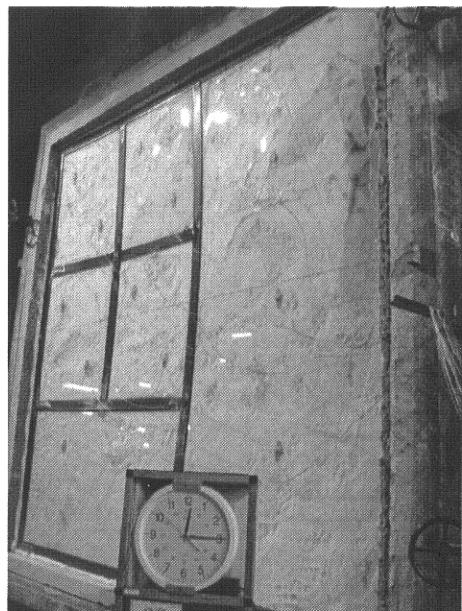
After 15 minutes.

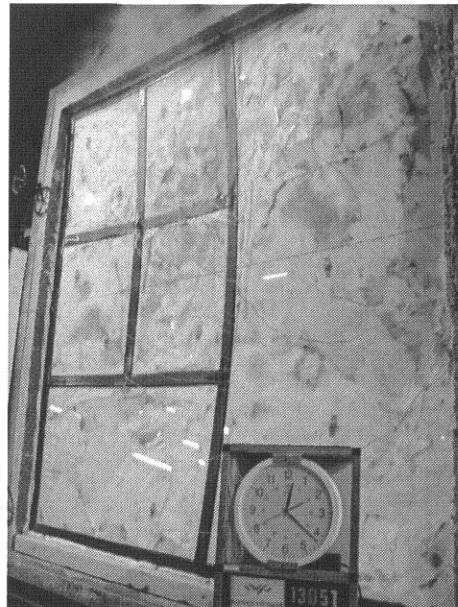
After 22 minutes.

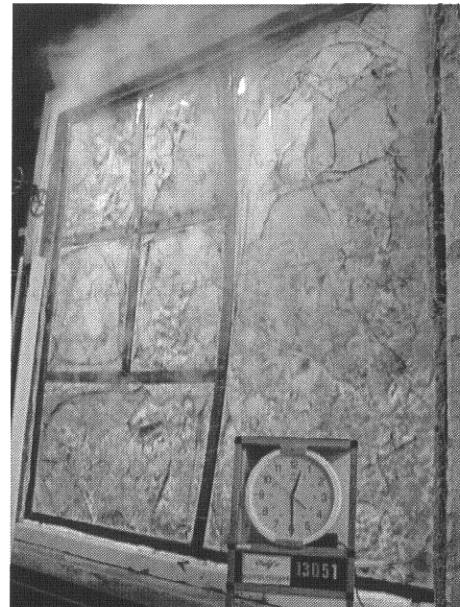
After 30 minutes.

30	A black discolouration is observed in the zones 6 till 9.
35	Sustained flaming is observed in the zones 10 and 11.
37	End of the test.

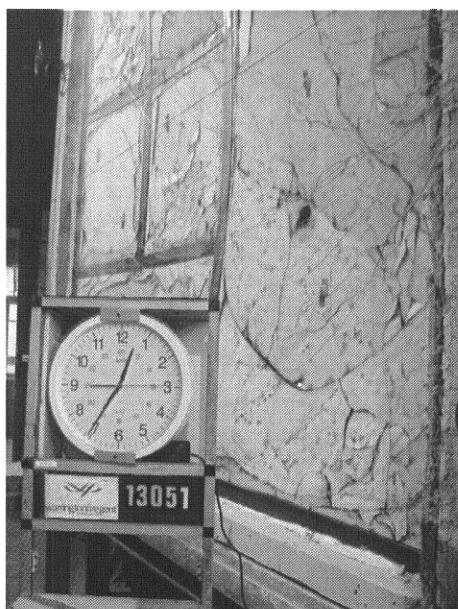
After 35 minutes.

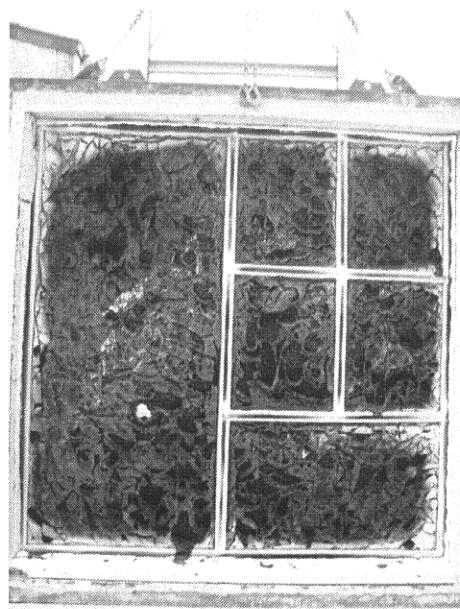
The exposed side after the test.
